Cold-water Aquatic Invasive Species Shoreline Survey and Warm-water Point-intercept Macrophyte Survey Little Sissabagama Lake - WBIC: 2394100 Sawyer County, Wisconsin

Endangered Resource Services, LLC

June 16 and August 8, 2022

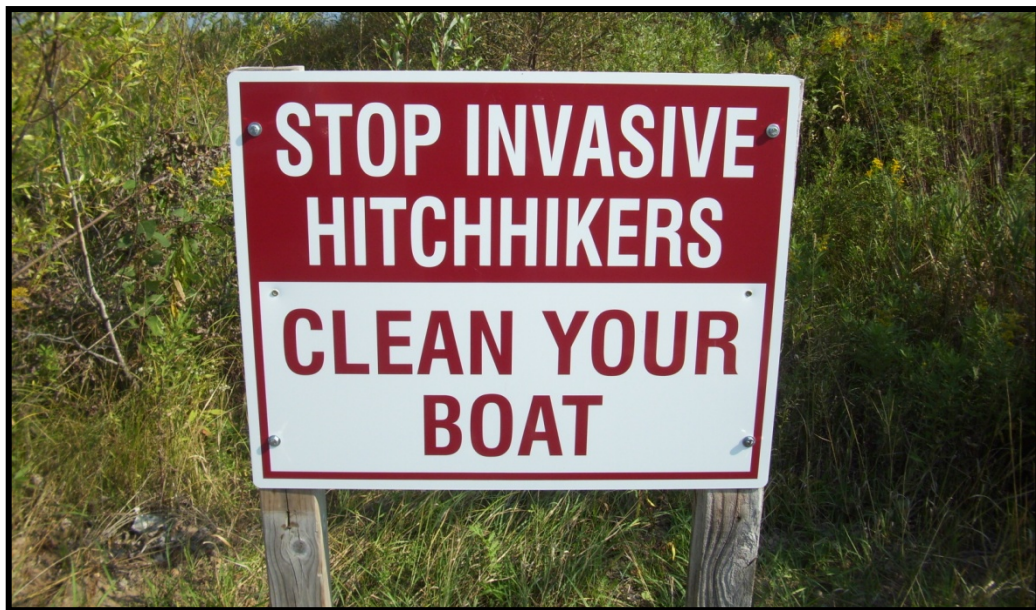
Figure 11: Potential Secondary Sign to be Placed Near the Water’s Edge

With no monitoring program in place, a small standard WDNR AIS sign is currently serving as the “guardian of the lake”. Adding a secondary sign that is located at the waterline is a potential actionable item for the LSLSA to consider. Hopefully, a simple bright sign will increase the chances that visitors will remember to check their boat carefully before launching (Figure 11).
